## **Pedicab Safety Evaluation**

**UPR SE/052/04**

**TRL Limited**

**Prepared for: Project Record: Pedicab Safety Evaluation**  
**Client: Licensed Taxi Drivers Association (LTDA)**  
**(Bob Oddy)**

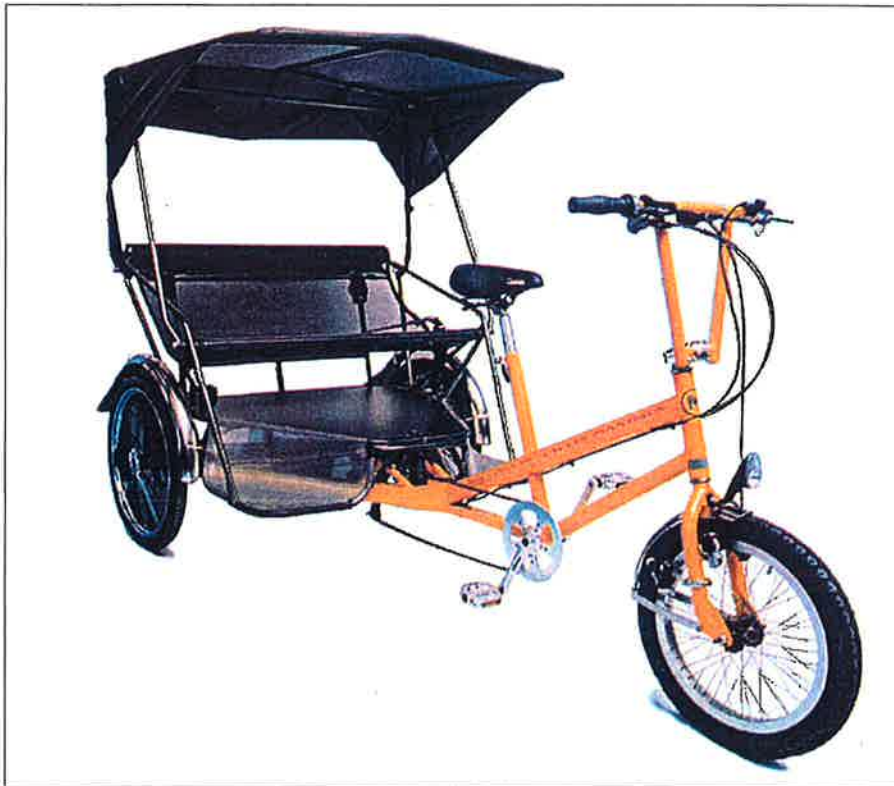
Figure 1: Test Vehicle

The vehicle weighed 75kg, had a wheelbase of 1.85m and a track of 1.2m. The vehicle was equipped with an eight speed derailleur driving a three speed hub. The vehicle was equipped with a chain driven differential driving a hollow rear axle. The front wheel had a hydraulic rim brake and the rear wheels had hydraulic disc brakes using 185mm diameter discs.

The rear seating compartment was fitted with one lap belt designed to restrain the passengers. It should be noted that although it is most common for a Pedicab to carry two passengers, they can carry three, all of which would be restrained by the single lap belt.

The LTDA supplied TRL with a sample Pedicab as illustrated in Figure 1.

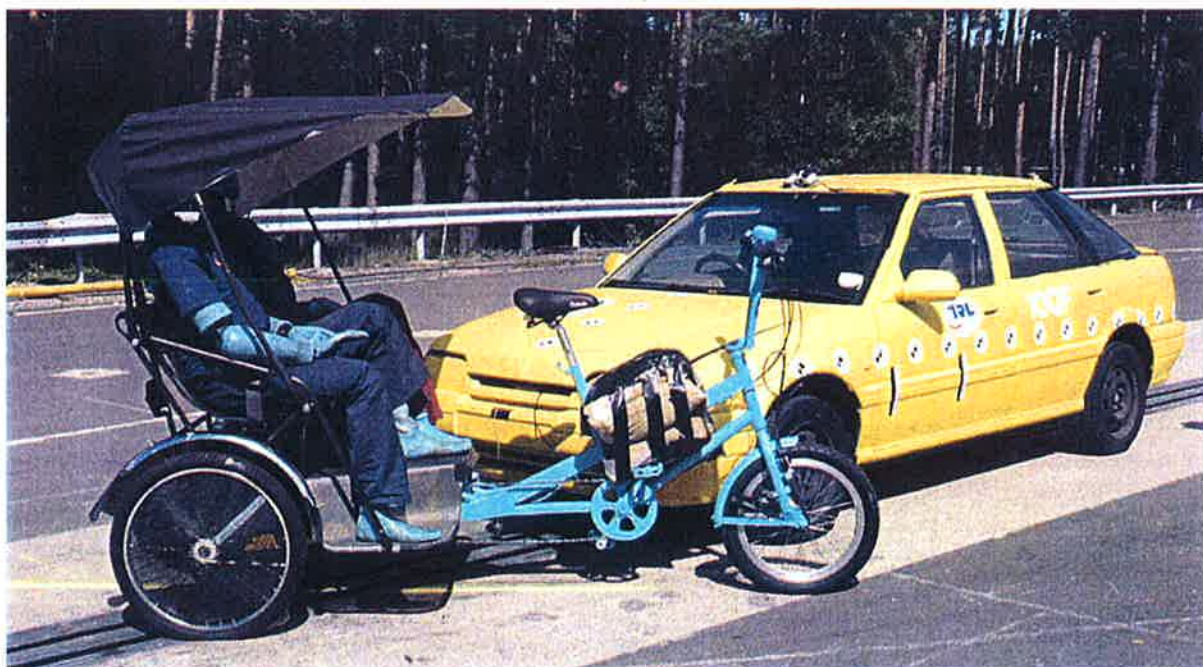
**Figure 11. Pre-impact vehicle positions**

The test aimed to simulate a collision where a Pedicab is impacted, at a junction, by a passenger car travelling at 48km/h (30miles/h). The angle between the longitudinal axis of the car and the longitudinal axis of the Pedicab was chosen to be 45 degrees, to represent the Pedicab turning right at, say, a cross-road junction, and being struck by a car travelling from left to right across the junction.

The test was performed in a large outdoor test area at TRL and the pre-impact positions of the two vehicles are shown in Figure 11 below. For the purpose of this test, the Pedicab was stationary prior to the impact.

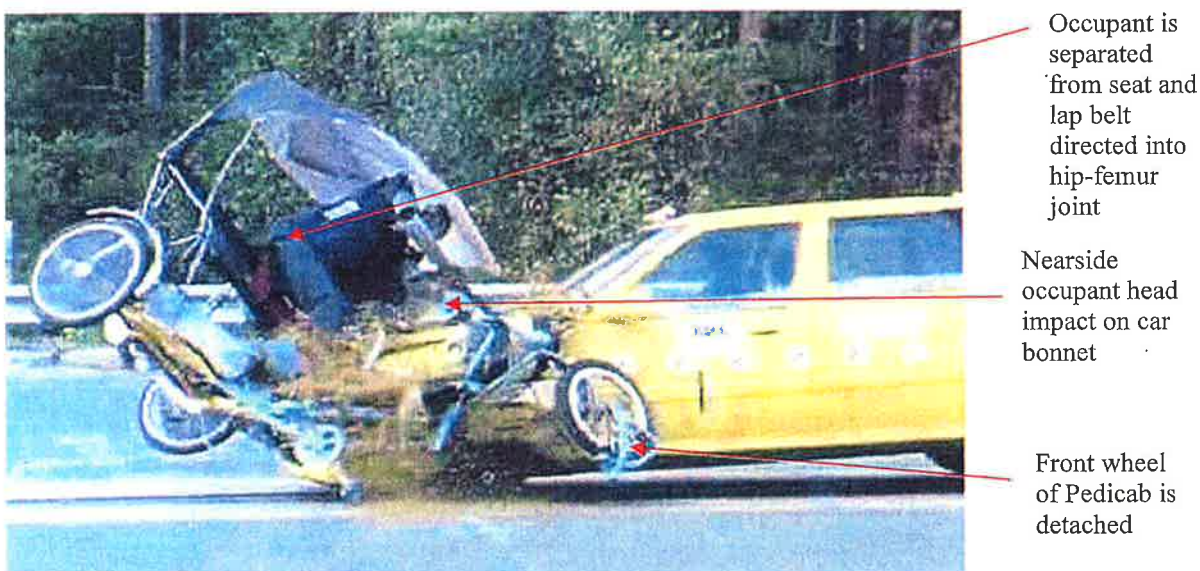
**Figure 13. Observations during impact**

- The first contact between the car and the Pedicab occupants occurs at 25ms when the leading edge of the car bonnet contacts the left lower leg of the nearside occupant. Although this contact does not cause any movement to the torso of the dummies, it may induce very large forces into the lower limbs of the nearside occupant.

- From 100ms to 200ms the Pedicab is lifted completely off the ground and rotates about the leading edge of the car bonnet and the dummies are accelerated to a velocity close to that of the car.

- The head of the nearside occupant makes contact with the bonnet of the car approximately 160ms after the initial contact between the vehicles
- The offside occupant is separated from the seat of the Pedicab, but this is restricted by the lap belt. However, the lap belt is directed into the joint between the hip and femur.
